ROBBINS LIBRARY

EXTERIOR ENVELOPE REPAIRS - BID NO. 18-16

ROBBINS LIBRARY
TOWN OF
ARLINGTON
700 MASSACHUSETTS AVENUE
ARLINGTON MA, 02476

COVER SHEET

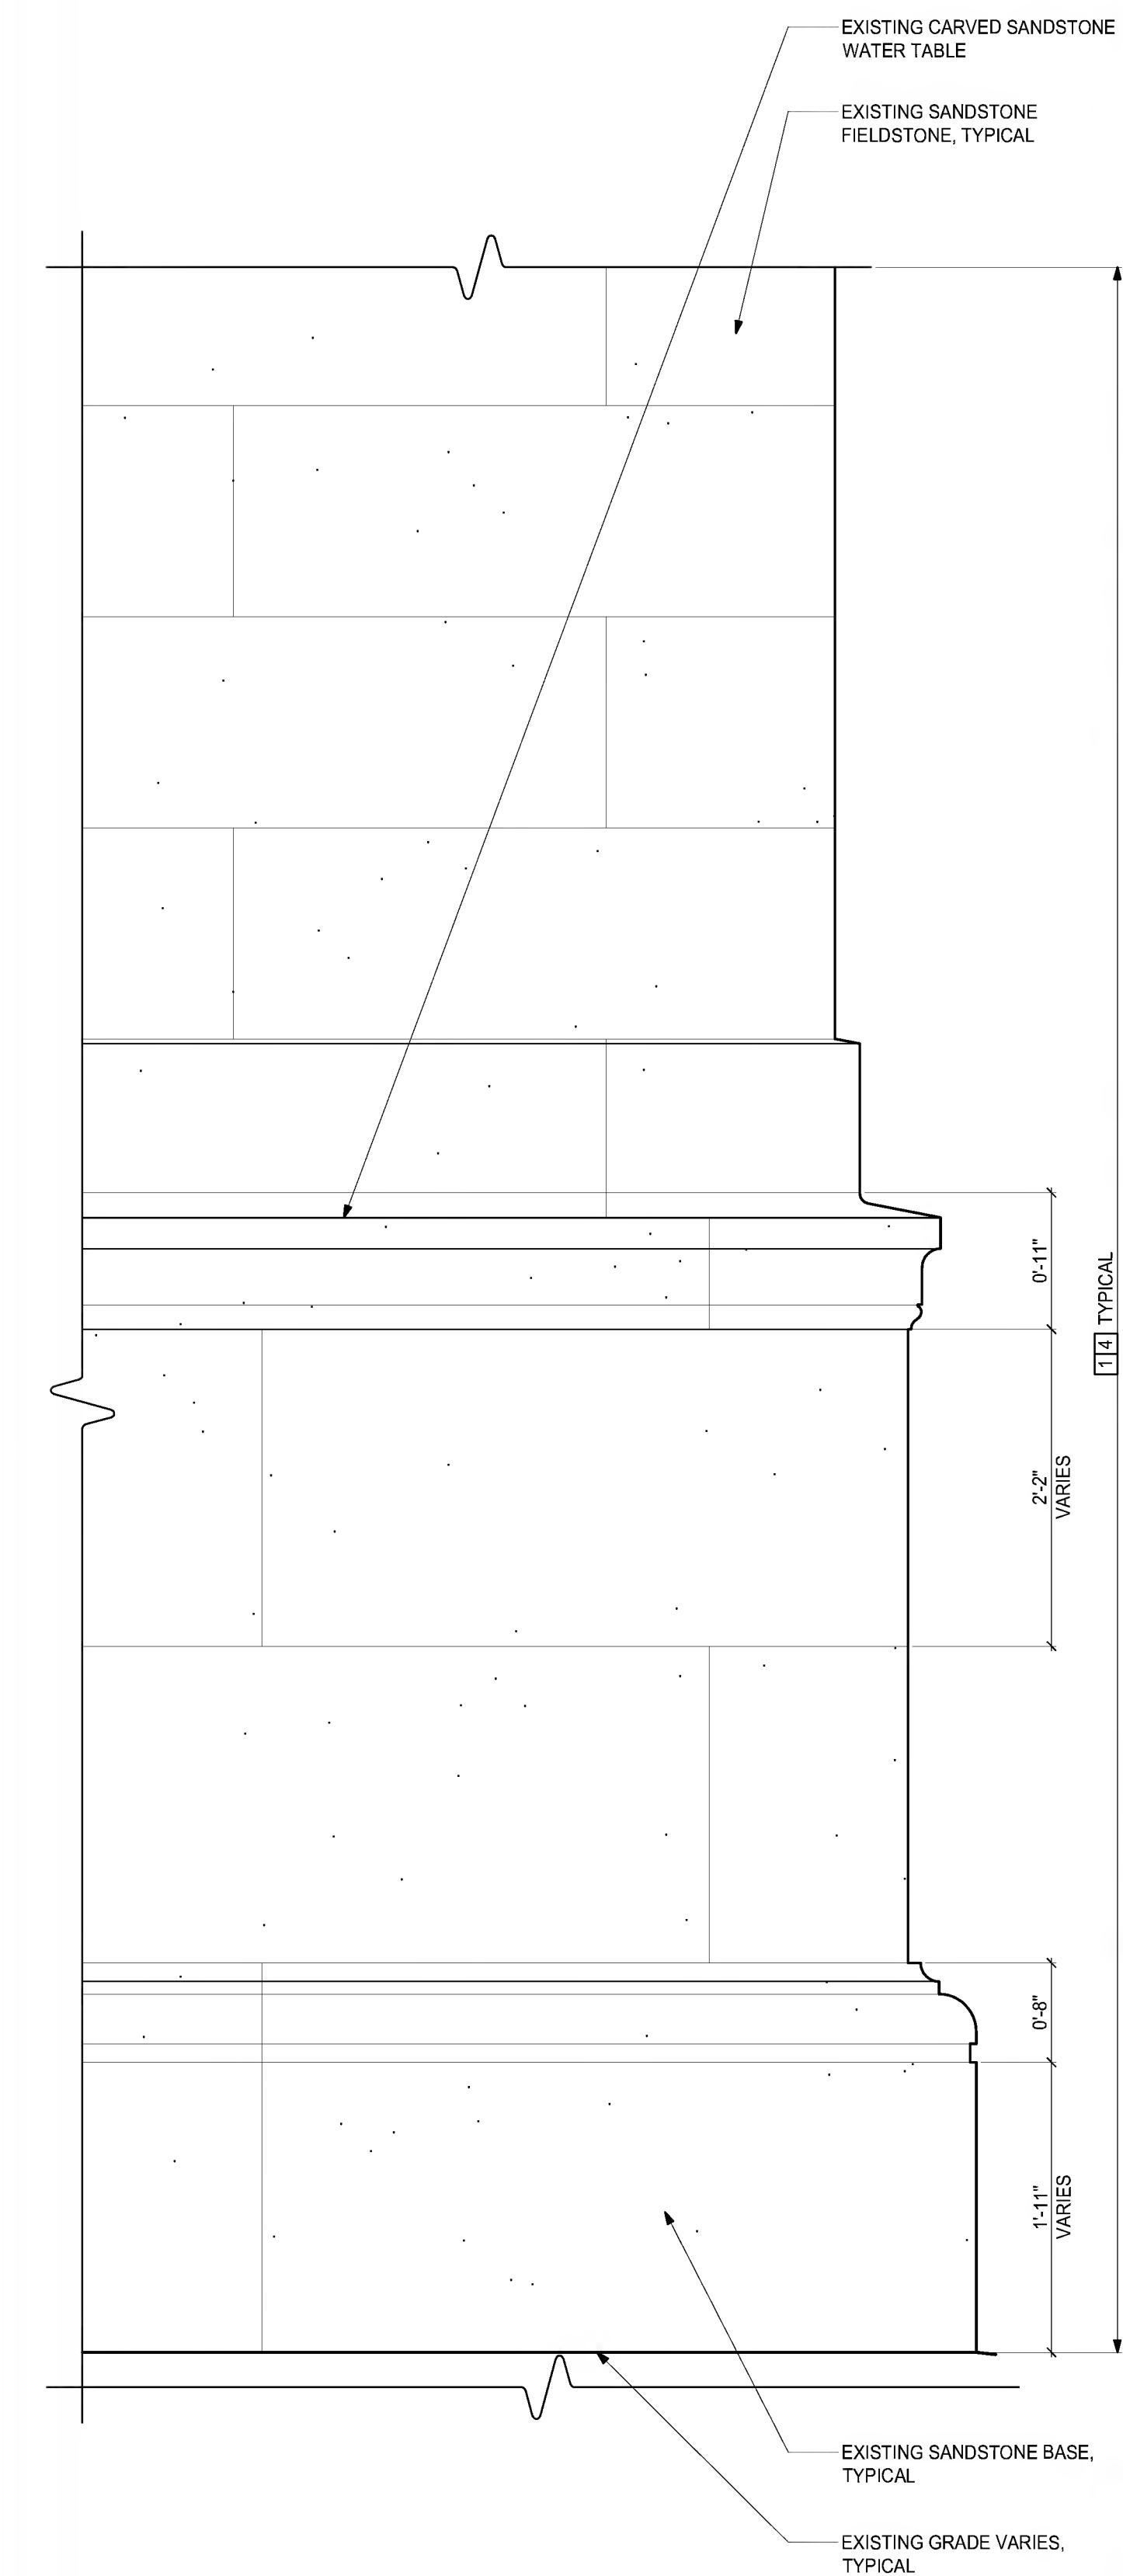
3 TYPICAL ENLARGED LOWER SANDSTONE WATER TABLE & FIELD STONE DETAIL

1. REFER TO DRAWING A2-01, A2-02, & A2-04 FOR TYPICAL REPAIR & RESTORATION WORK NOTES.

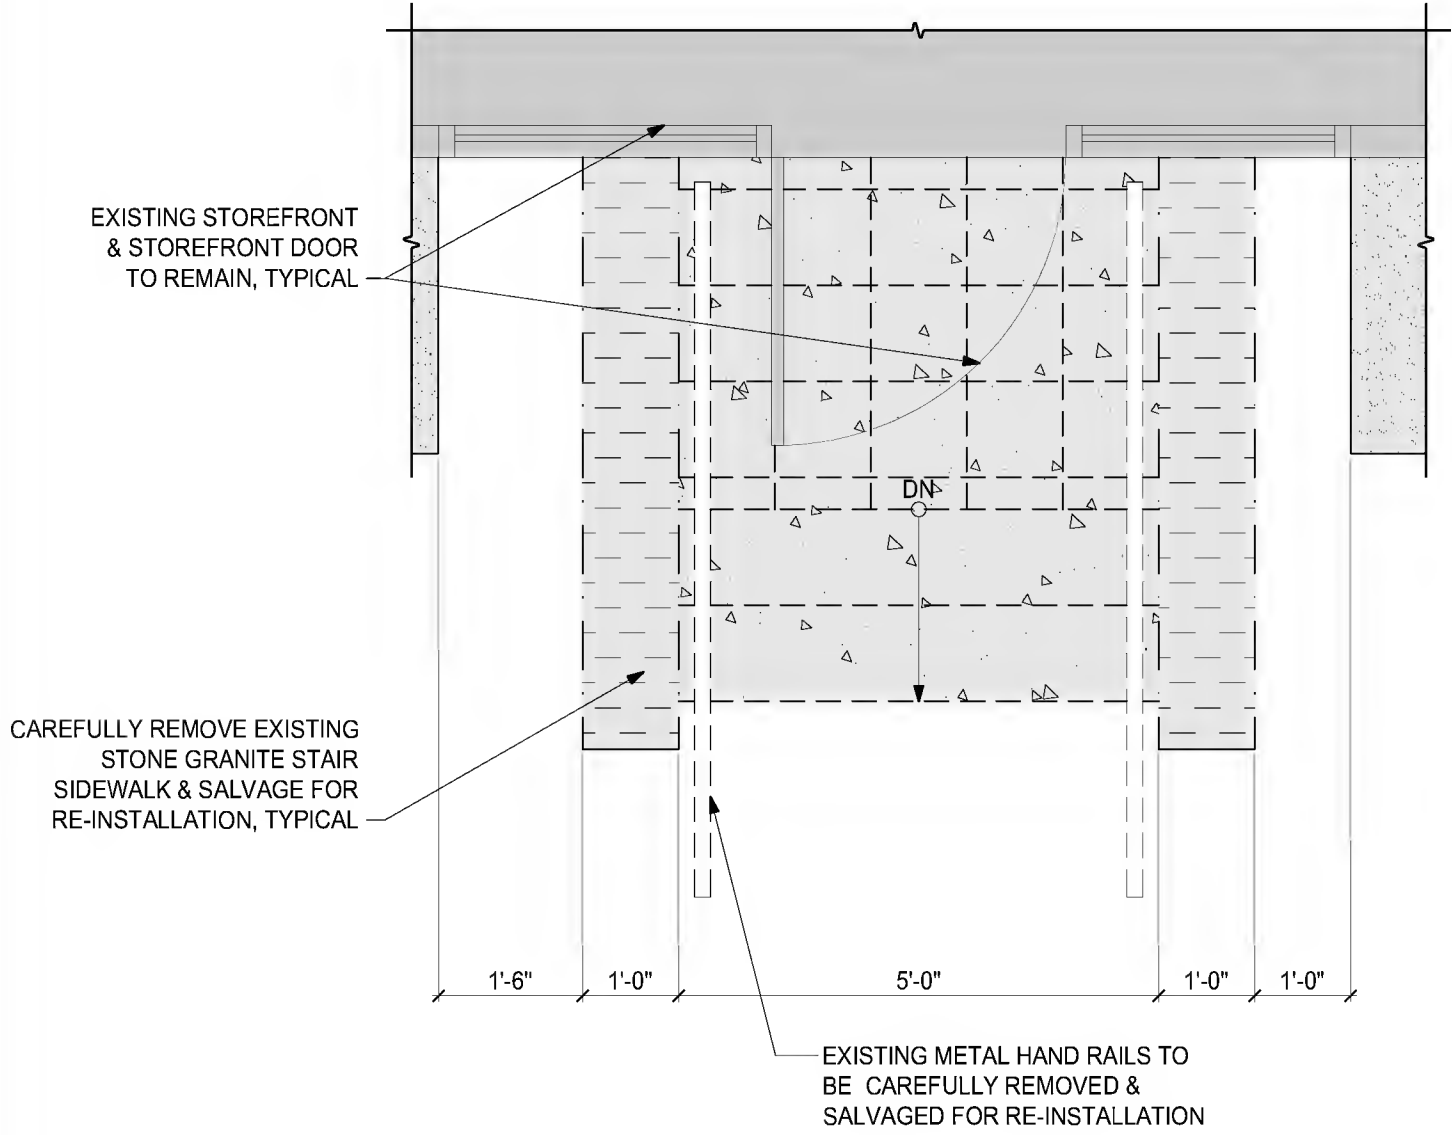
1 CONCRETE STAIR & METAL HANDRAIL DEMO PLAN
SCALE: 1/2"=1'-0"

NOTE: SOLID LIGHT GRAY HATCH (▨) REPRESENTS EXISTING CONSTRUCTION TO REMAIN.

NOTE: SEE NOTE NO. 14 ON SHEETS A2-01 - A2-04

- EXCAVATE, EXPOSE, REMOVE AND DISPOSE OF EXISTING CONCRETE STAIRS AND FOUNDATION IN ITS ENTIRETY, INCLUDING CONCRETE PAVERS ON TOP LANDINGS.
- FORM AND PLACE NEW REINFORCED CONCRETE FOOTINGS, WALLS AND STAIRS, AND RESET EXISTING GRANITE SIDEWALLS, ANCHORED AND PINNED TO NEW CONCRETE FOUNDATION. CAST RESTORED HANDRAILS AND POSTS INTO CONCRETE.

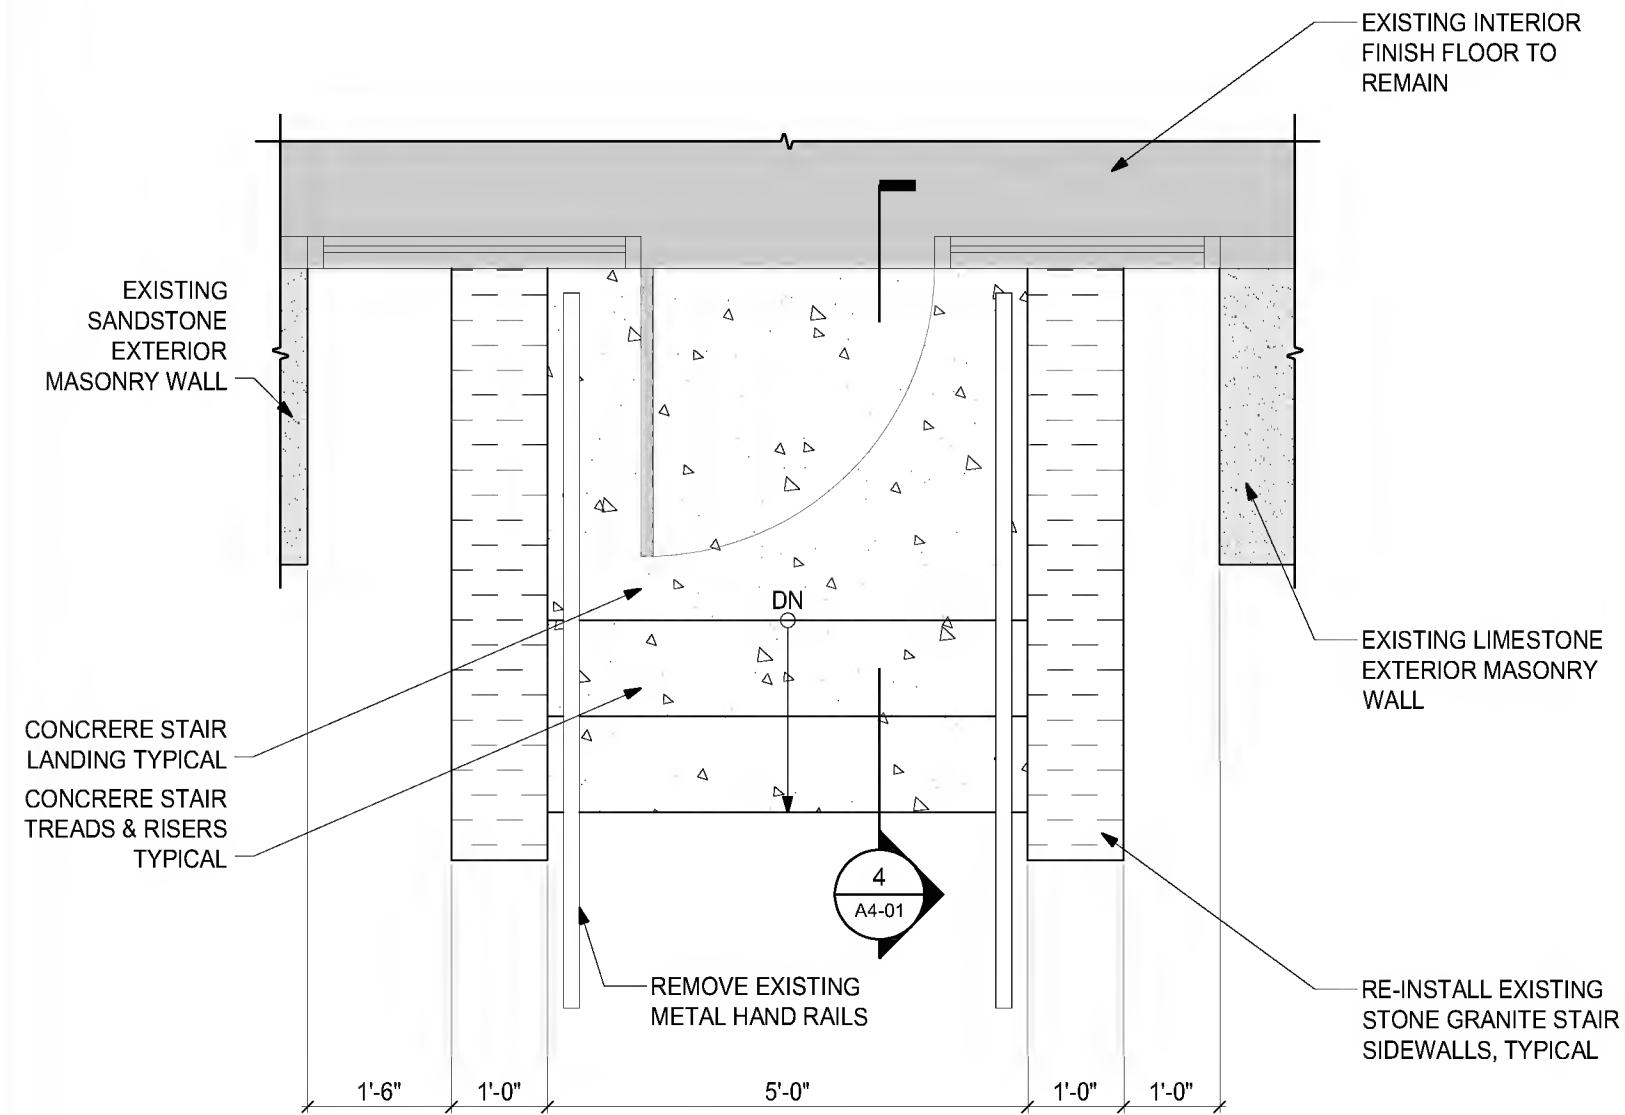
2 CONCRETE STAIR & METAL HANDRAIL PLAN
SCALE: 1/2"=1'-0"

NOTE: SOLID LIGHT GRAY HATCH (▨) REPRESENTS EXISTING CONSTRUCTION TO REMAIN.

NOTE: SEE NOTE NO. 14 ON SHEETS A2-01 - A2-04

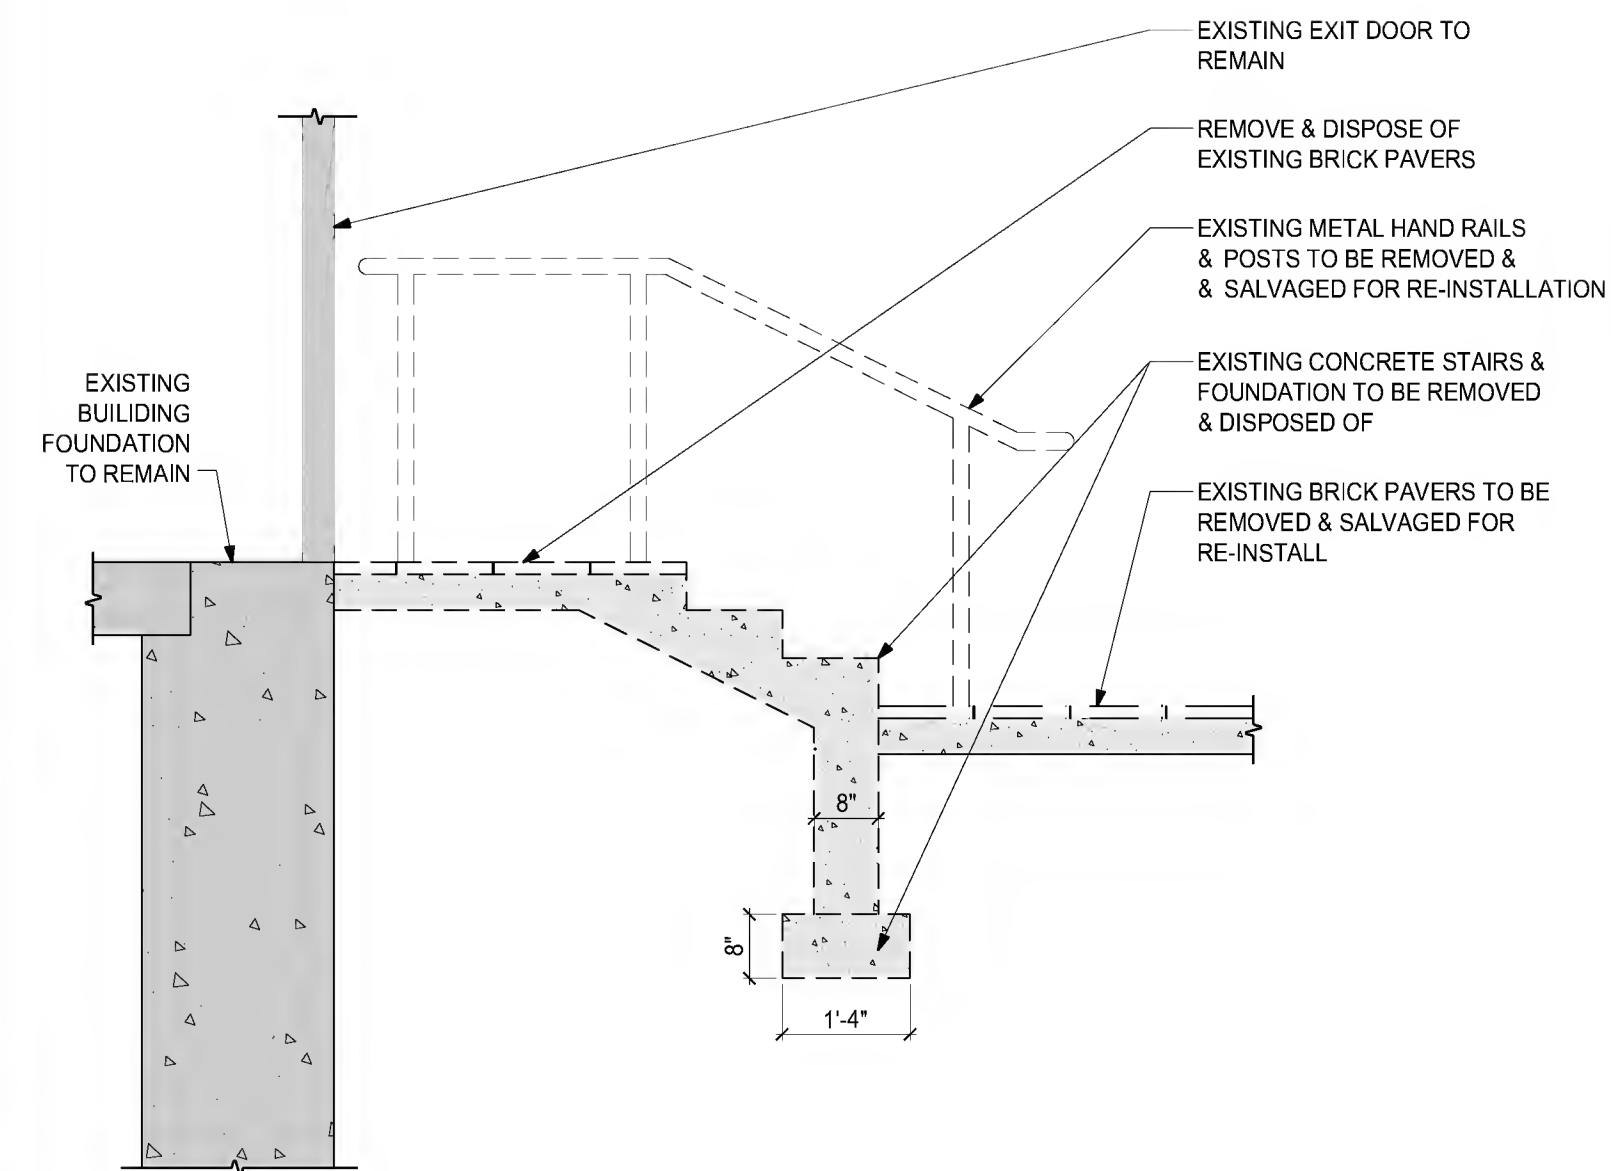
3 CONCRETE STAIR & METAL HANDRAIL DEMO SECTION
SCALE: 1/2"=1'-0"

NOTE: SOLID LIGHT GRAY HATCH (▨) REPRESENTS EXISTING CONSTRUCTION TO REMAIN.

NOTE: SEE NOTE NO. 14 ON SHEETS A2-01 - A2-04

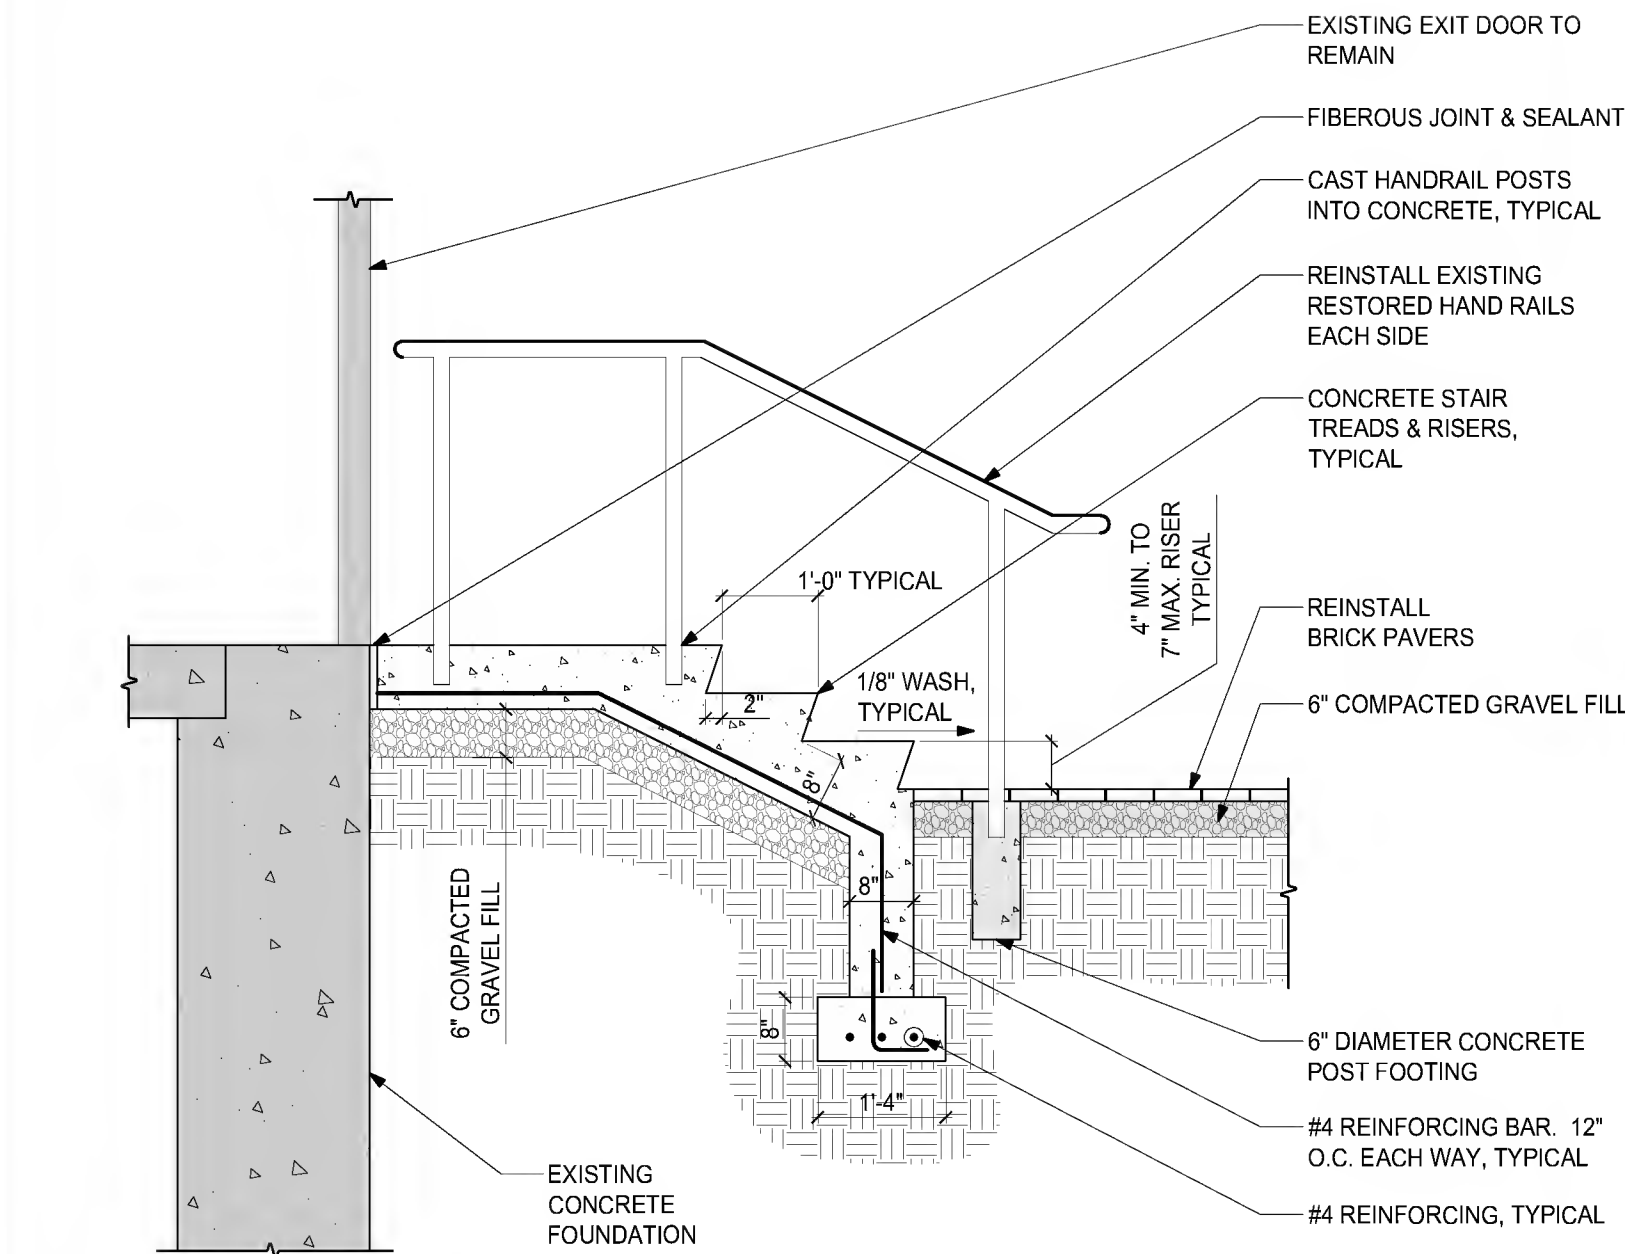
4 CONCRETE STAIR & METAL HANDRAIL SECTION
SCALE: 1/2"=1'-0"

NOTE: SOLID LIGHT GRAY HATCH (▨) REPRESENTS EXISTING CONSTRUCTION TO REMAIN.

NOTE: SEE NOTE NO. 14 ON SHEETS A2-01 - A2-04

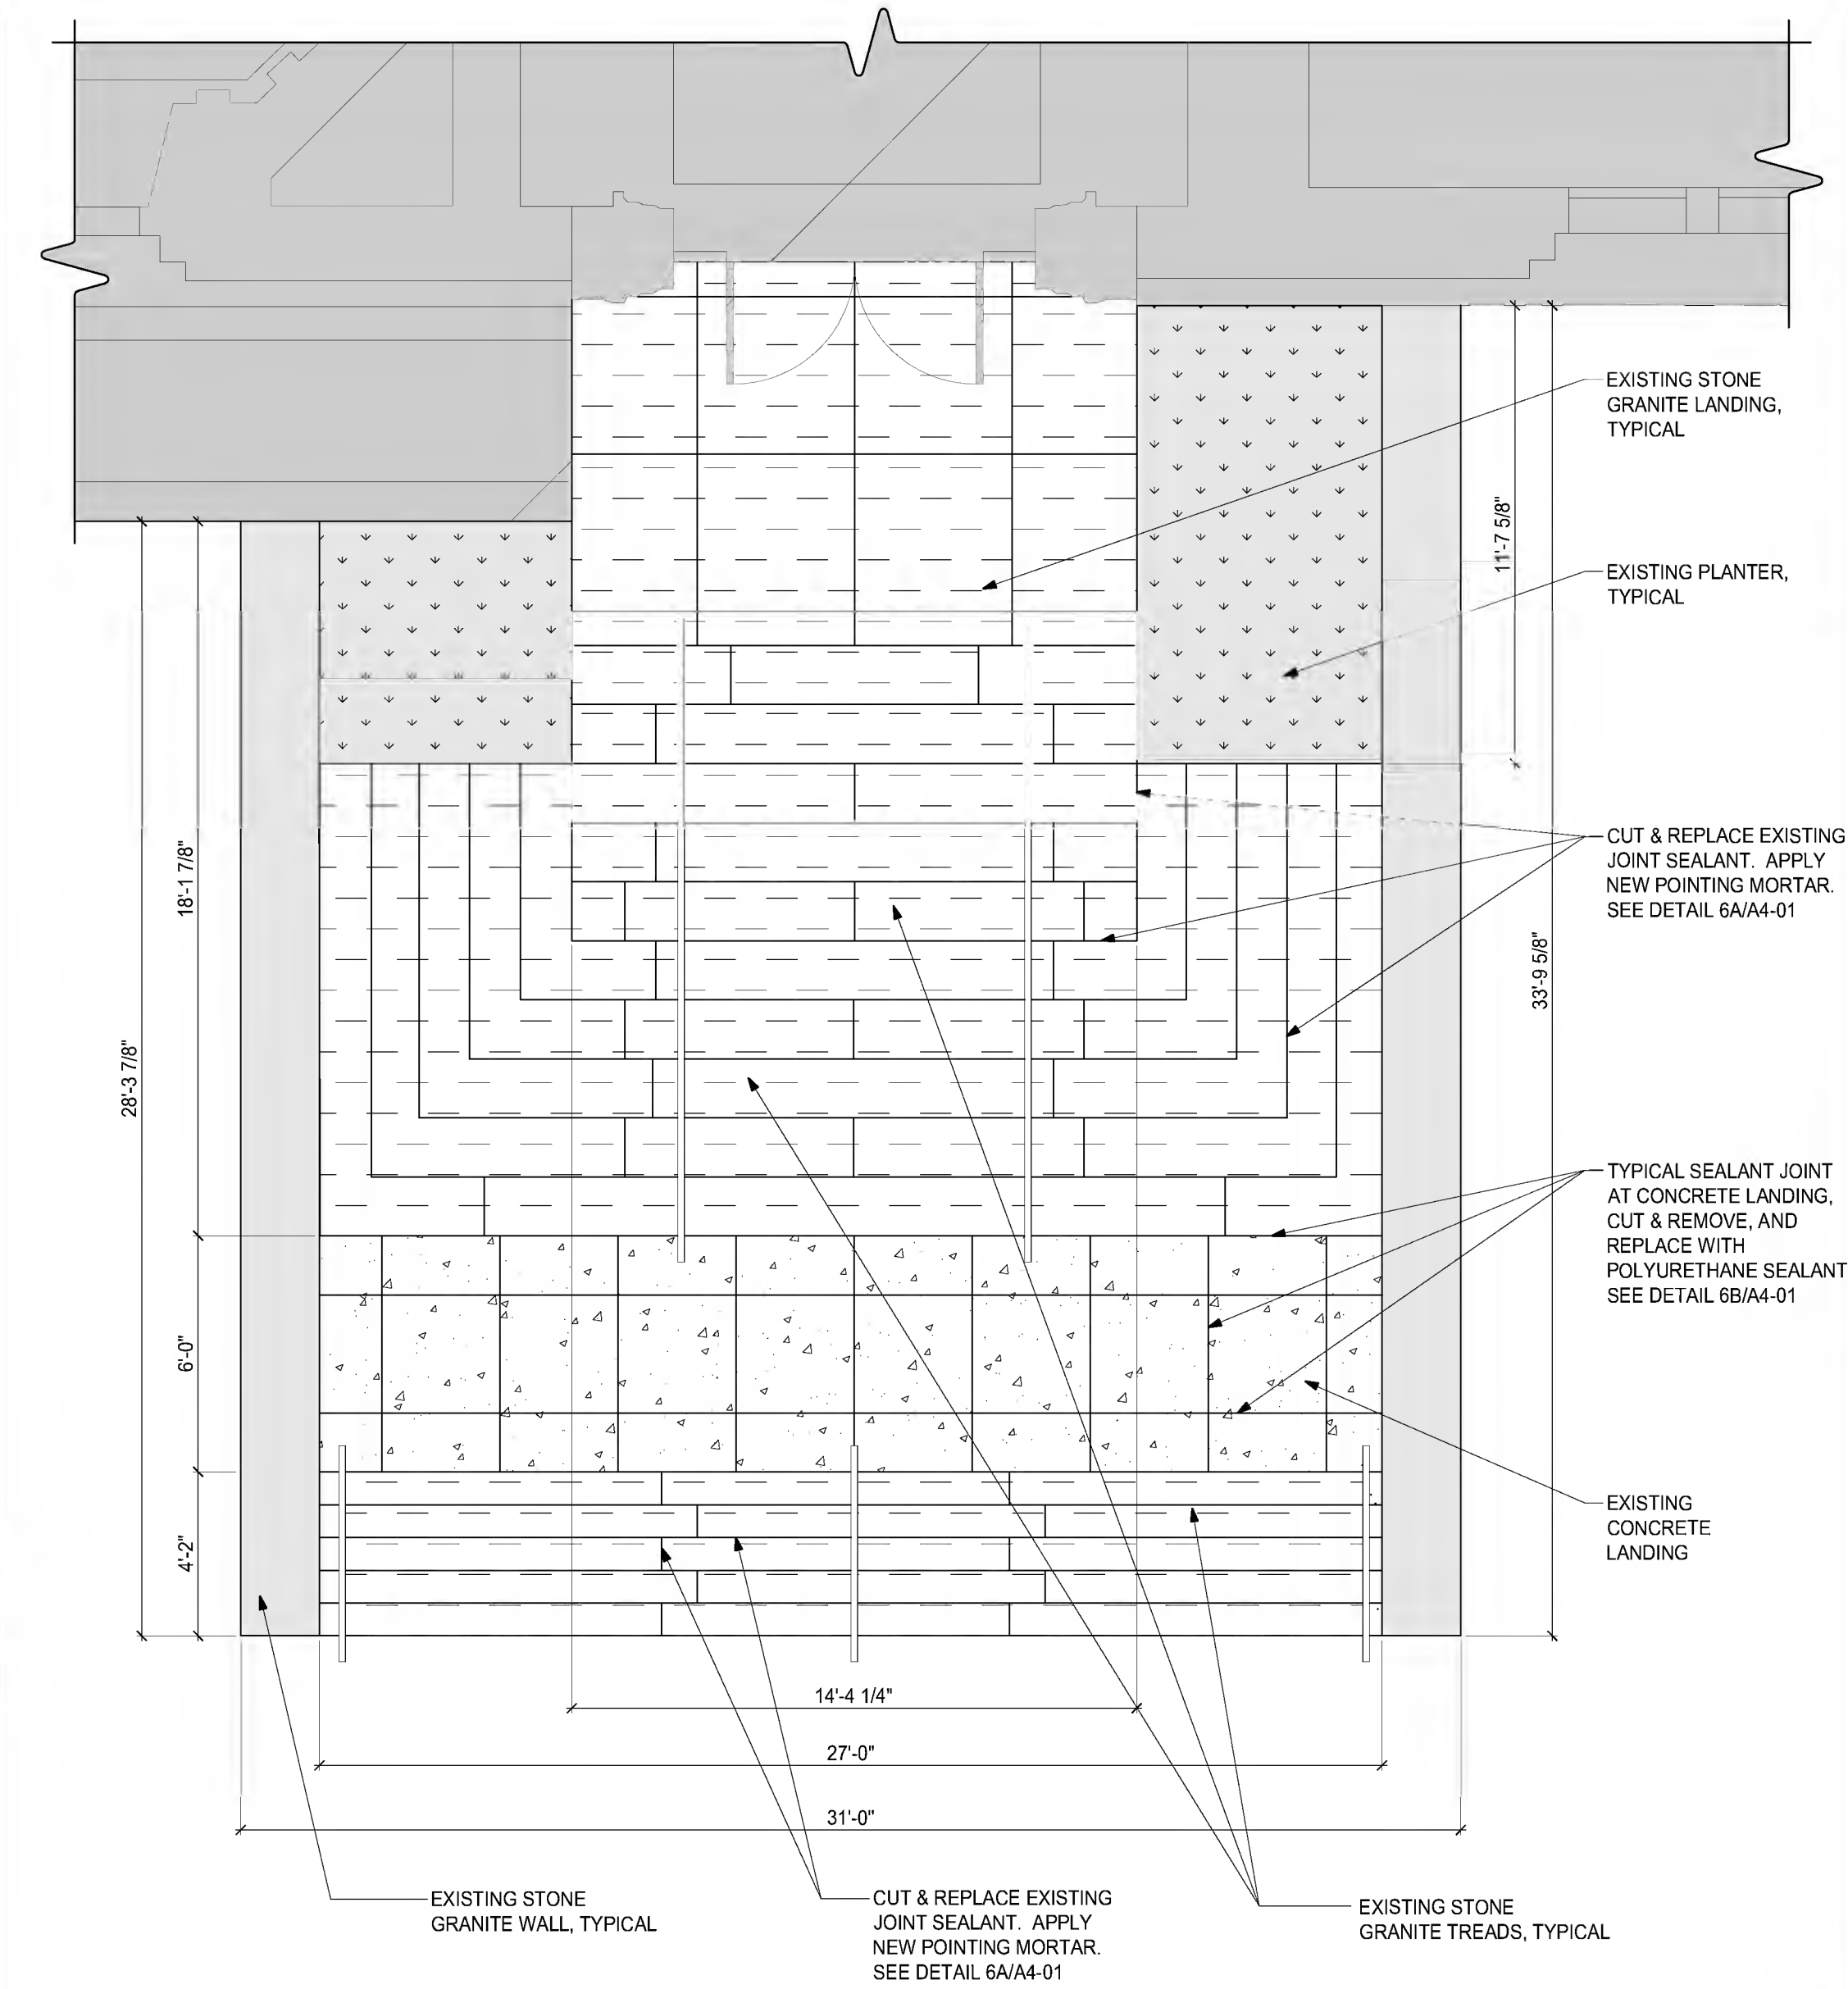
5 MAIN ENTRY STAIR PLAN
SCALE: 1/4"=1'-0"

NOTE: SOLID LIGHT GRAY HATCH (▨) REPRESENTS EXISTING CONSTRUCTION TO REMAIN.

NOTE:
DEDUCT ALTERNATE NO.4 - ELIMINATE ALL WORK ASSOCIATED TO POWER WASH AND TO POINT EXTERIOR GRANITE STONE STAIRS AND TO RESEAL CONCRETE LANDING AT MAIN ENTRANCE OF THE 1890'S LIBRARY BUILDING.

- REPLACE EXISTING SEALANT AND MORTAR JOINTS OF THE EXTERIOR GRANITE STONE STAIRS, WITH INTERMEDIATE CONCRETE LANDING AT MAIN ENTRANCE OF THE 1890'S LIBRARY BUILDING. CUT, REMOVE AND DISPOSE OF 100% ALL EXISTING VERTICAL AND HORIZONTAL JOINT SEALANTS, INCLUDING UNDERLYING MORTAR A MINIMUM OF 1-1/2 INCHES OR UNTIL SOUND MORTAR FROM ALL GRANITE STONE STAIR AND CONCRETE LANDING JOINTS. APPLY NEW POINTING MORTAR TO WITHIN 1/2-INCH OF THE SURFACE AND APPLY POLYURETHANE SEALANT TO ALL GRANITE STONE JOINTS AND CONCRETE LANDING JOINTS. STAIRS SHALL BE POWER WASHED CLEANED. REFER TO DEDUCT ALTERNATE NO. 5.

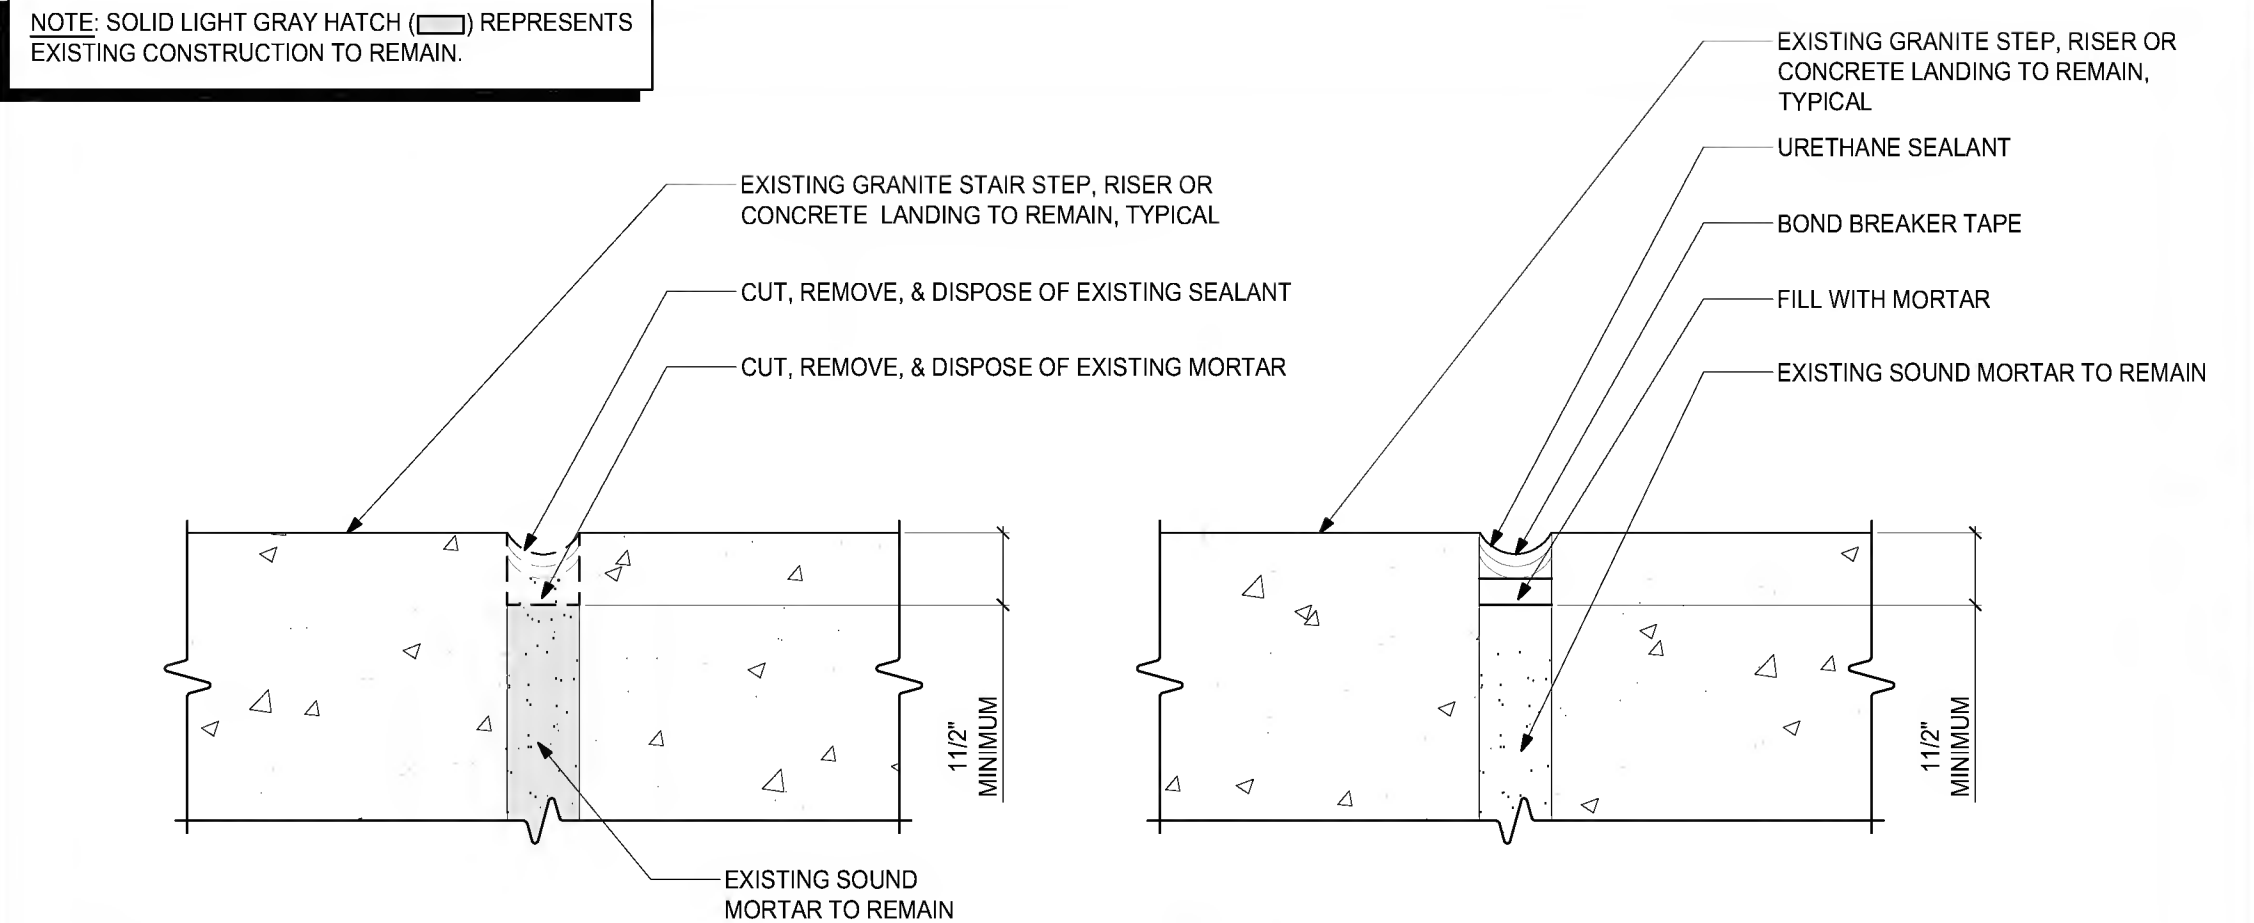
6A TYPICAL POINTING OF GRANITE STONE STAIR JOINT DETAIL
SCALE: 3/8"=1'-0"

NOTE: SOLID LIGHT GRAY HATCH (▨) REPRESENTS EXISTING CONSTRUCTION TO REMAIN.

6B TYPICAL CONCRETE LANDING SEALANT JOINT DETAIL
SCALE: 3/8"=1'-0"
